**The East Centre, 37 Front Street,  
Prudhoe, Northumberland  
NE42 5DQ**

**Pre-Acquisition Survey Report**

**27<sup>th</sup> June 2019  
Job Ref: 191599**

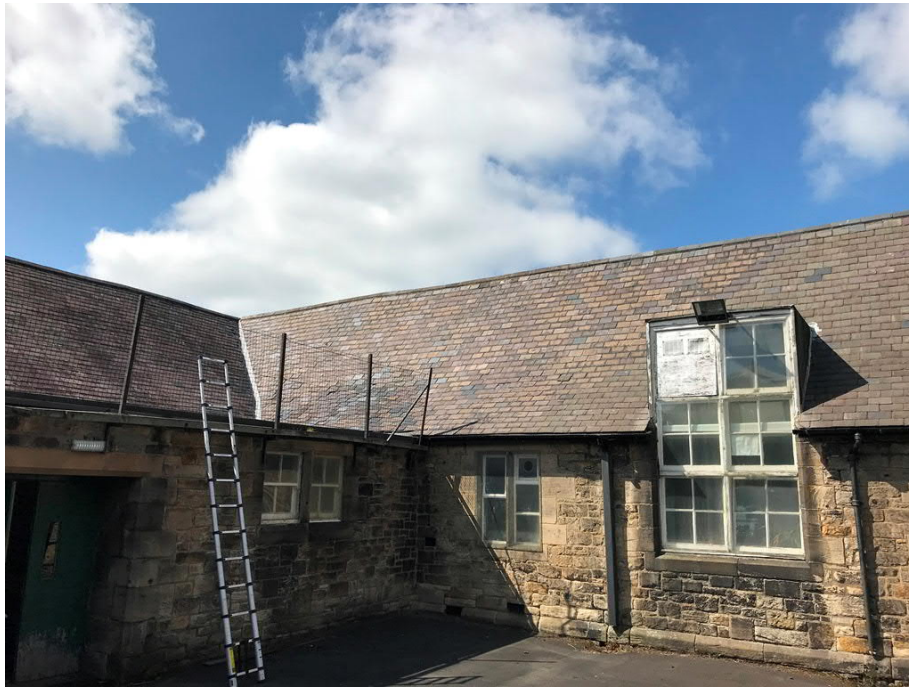
1. General view of the south and east facing roof slopes to The East Centre

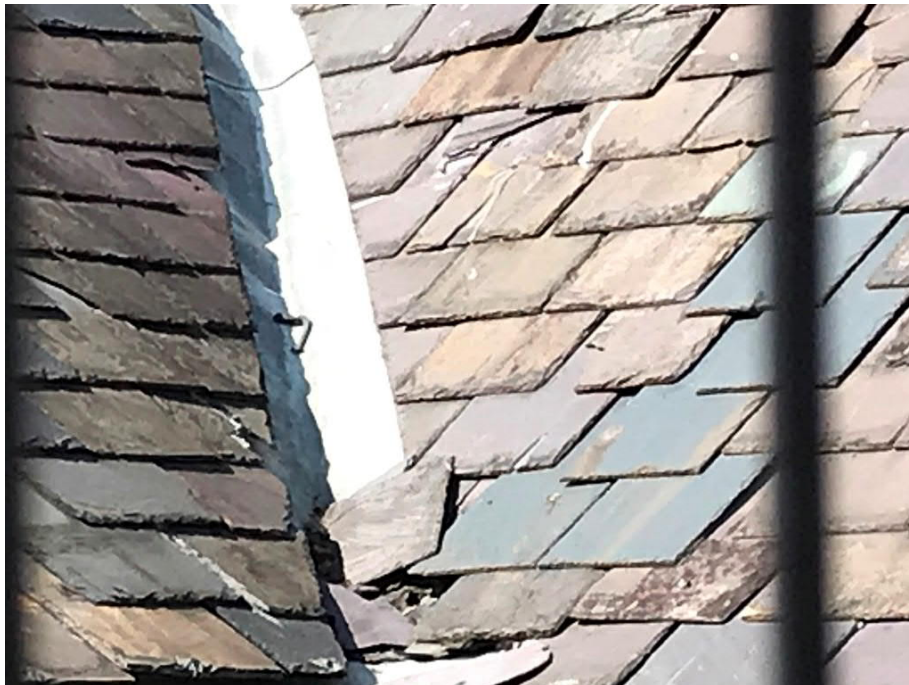
To the northeast corner of the east facing roof slope several tiles were noted to have slipped and had become dislodged with the valley tiles observed to be out of alignment and cracked in areas. This part of the roof slope is in poor condition and in our opinion will need to be stripped and recovered in order to remedy the defects observed.

2. Dislodged tiles to the south east valley to The East Centre

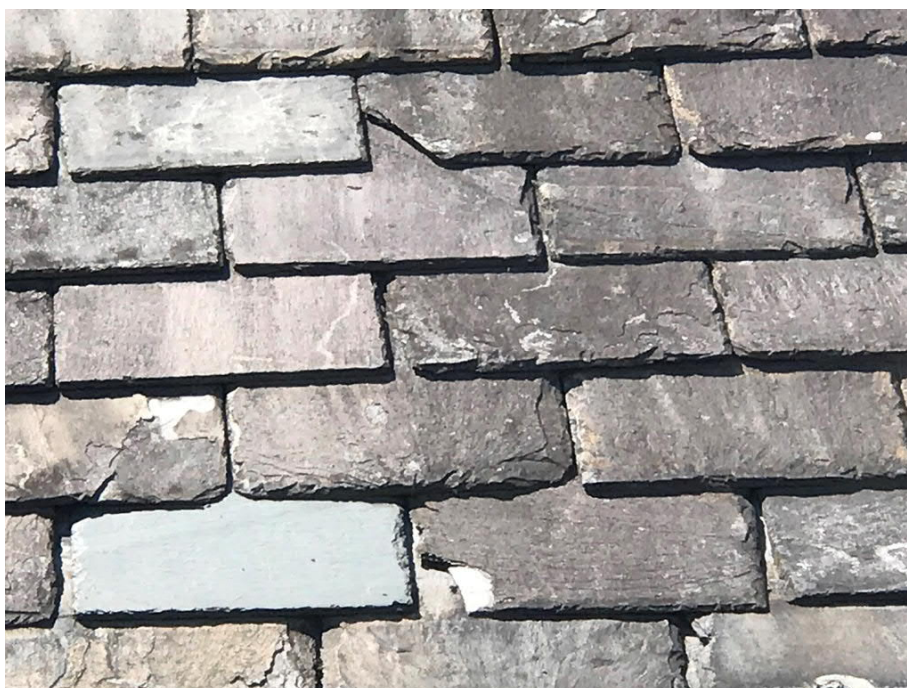
3. Cracked and rounded slates to The East Centre

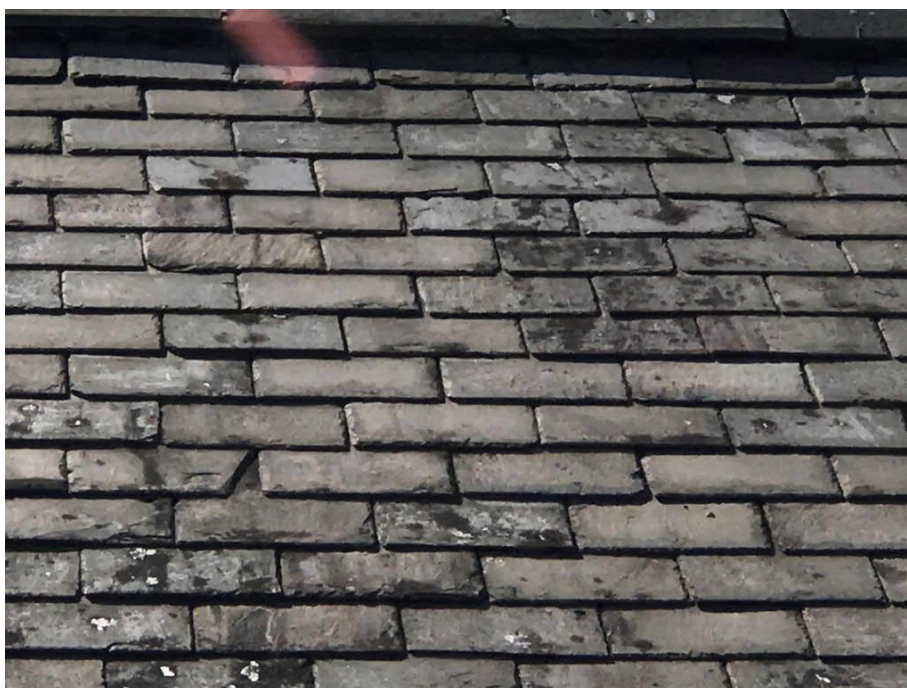
4. Cracked and rounded slates to The East Centre

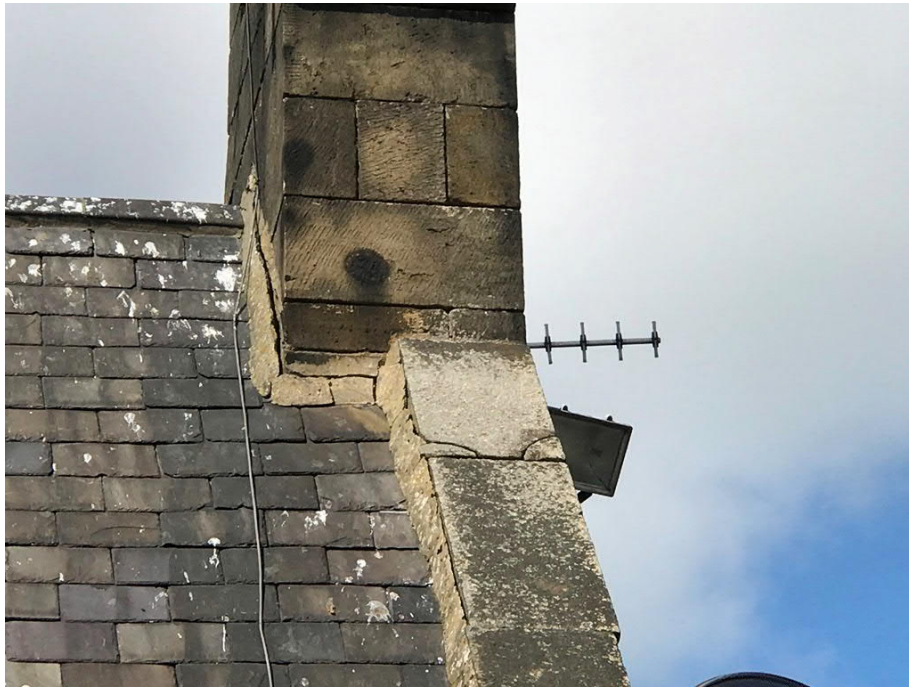
The mortar haunching surrounding the east facing bell tower arrangement, to the east gable elevation was noted to have cracked and appeared to have moved away from the back and base of the stonework, along with a cracked and defective section of stone to the water tabling being evident to the south roof slope. The individual water table sections themselves appeared to be out of plumb also. In this regard, we recommend that the mortar haunching is completely removed and repointed with the cracked and defective

5. Cracked haunching to the bell tower arrangement to The East Centre

section of water table observed replaced in its entirety with the remaining section of water table rebbed and reset.

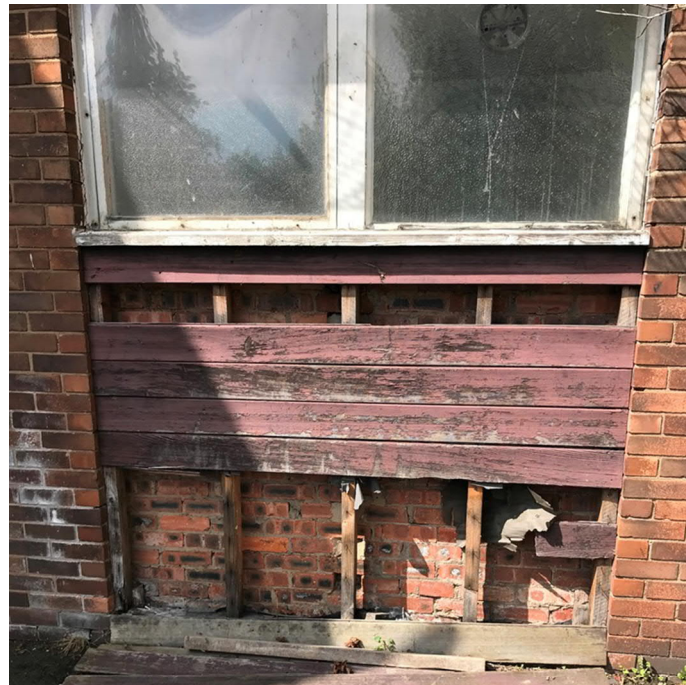
6. Missing and defective T&G cladding to The East Centre

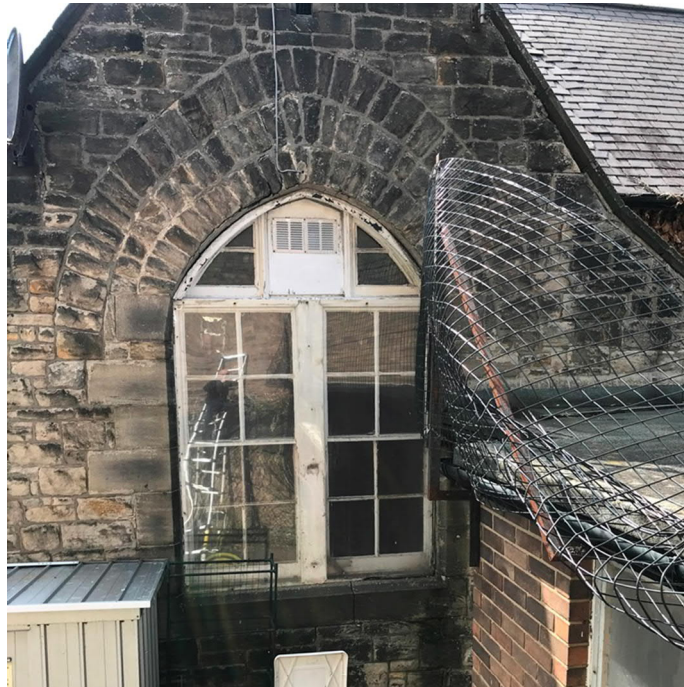
7. Cracking to the east elevation to The East Centre

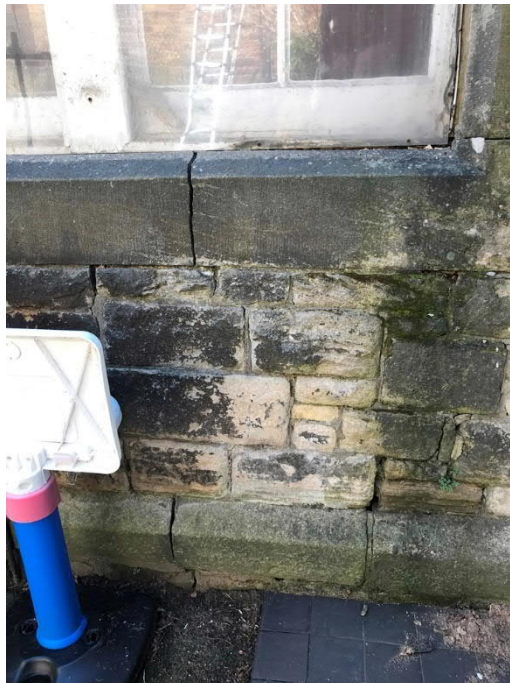
8. Cracking beneath the window of the east elevation to The East Centre

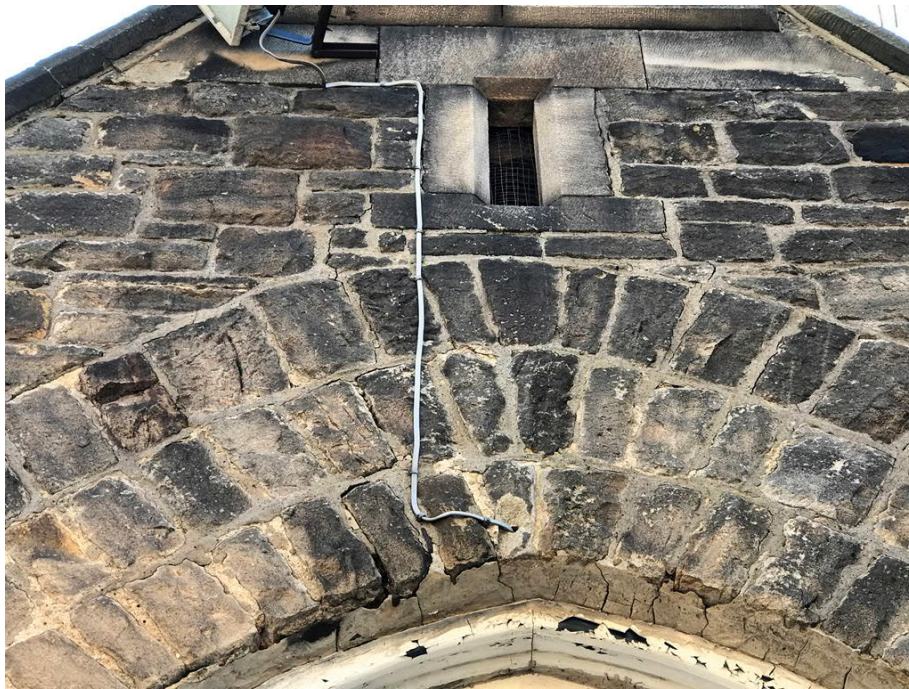
9. Cracking to head of window within the east elevation to The East Centre

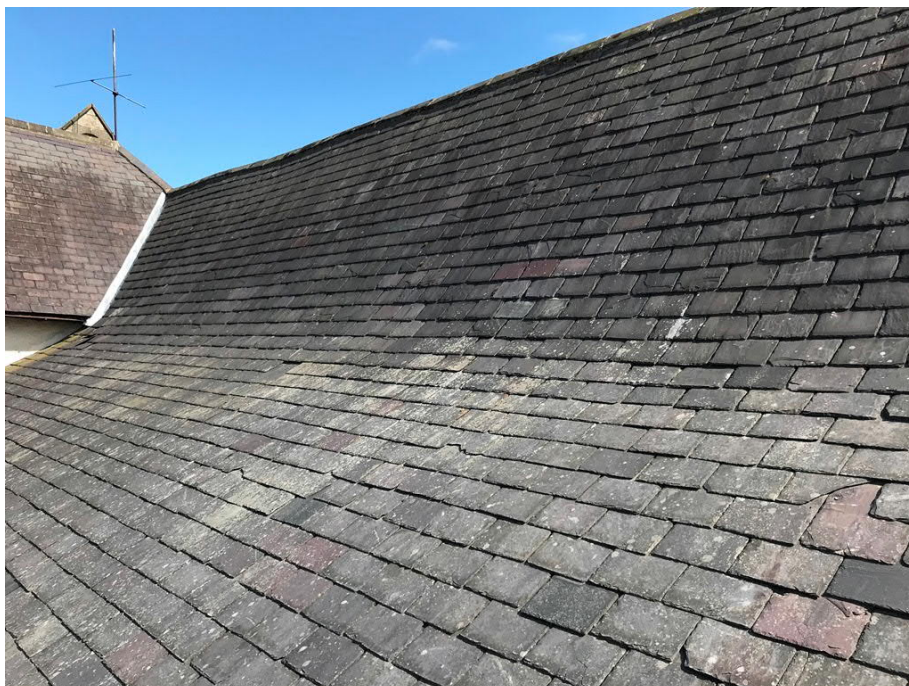
The north facing pitched roof slope was noted to be in a similar condition to that of the surrounding pitched roof slopes with rounded, cracked, slipped and deteriorated slates noted throughout. Adjacent to the right hand side valley, uplifted, missing and cracked slates were apparent which will require complete replacement in order to prevent water ingress from occurring.

10. General view of the north pitch roof slope with cracked and round slates to The East Centre

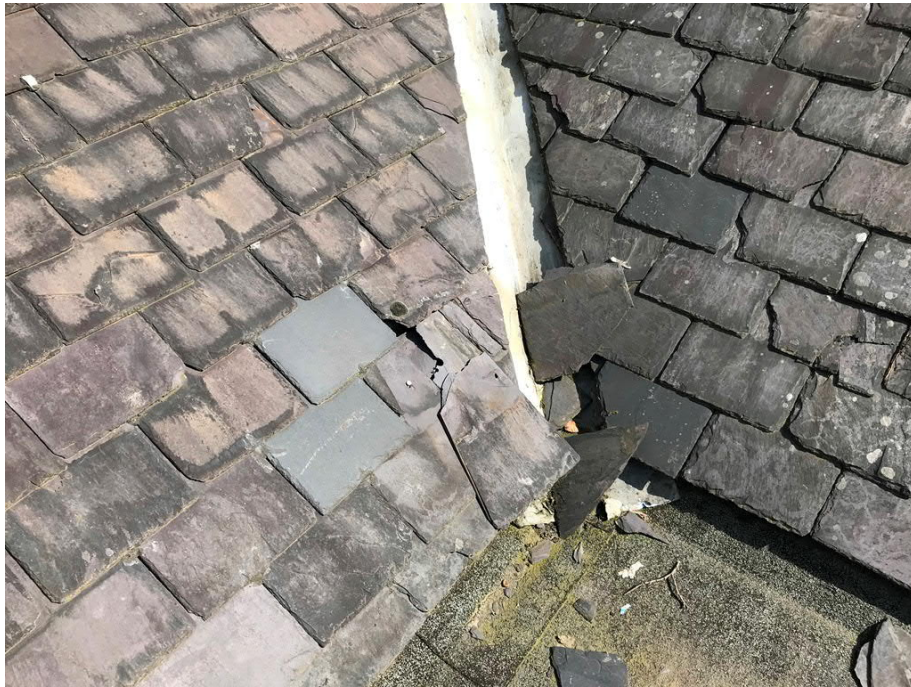
11. Cracked and defective slates to the north roof slope to The East Centre

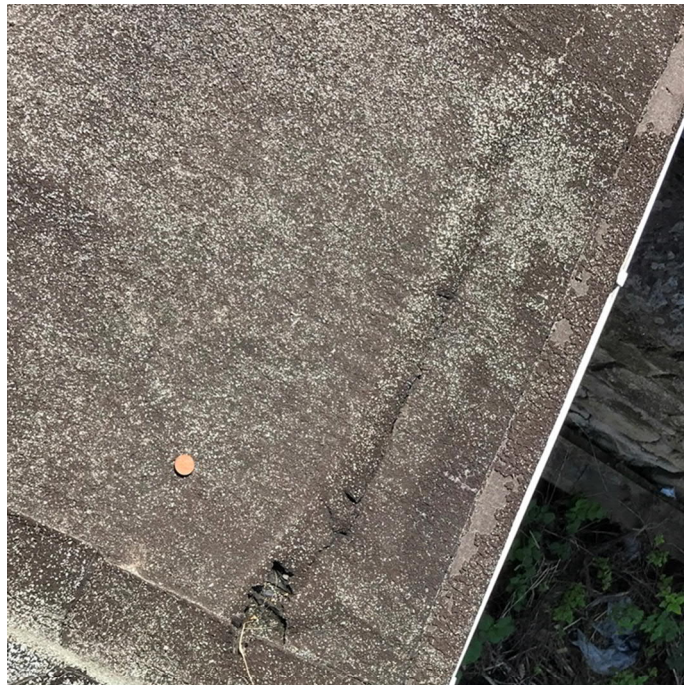
Now moving onto the north flat roof area, whilst it was noted to be generally in good order, it was showing signs of deterioration with bear areas beginning to occur. This was evident in particular to the front left hand corner where a section of the covering was noted to be badly blistered and holed, this will no doubt lead to water penetration internally if not repaired. A small section of guttering was also missing to the front edge, approximately 0.5m in length which should also be replaced. Notwithstanding this consideration to the overlaying of the area should be given within the next 3-5 years.

12. Blistered section of felt to the north flat roof area to The East Centre

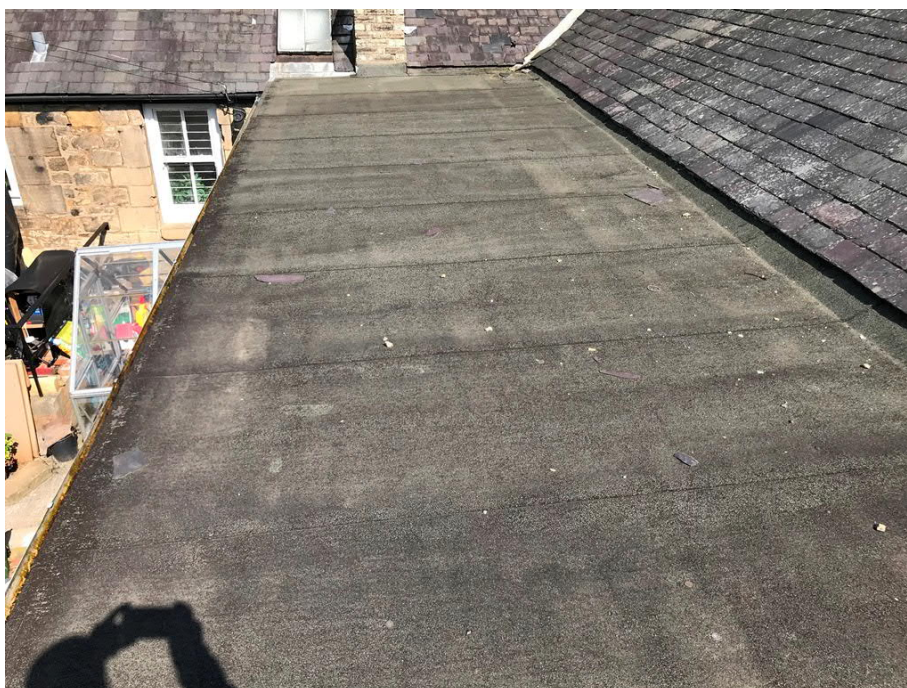
13. General view of the north flat roof section to The East Centre

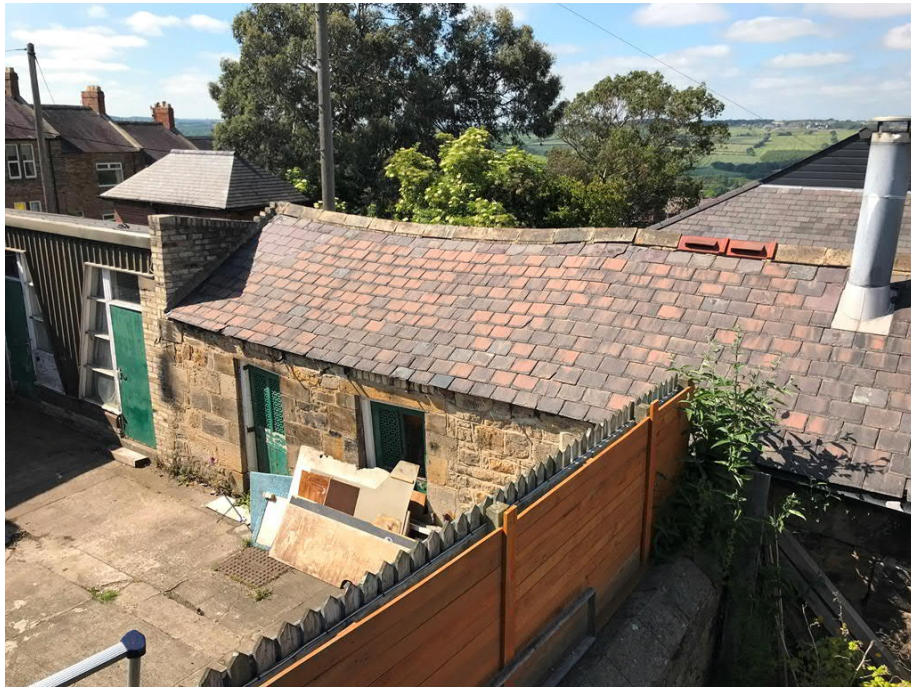
15. General view of the roof undulation to the outbuilding

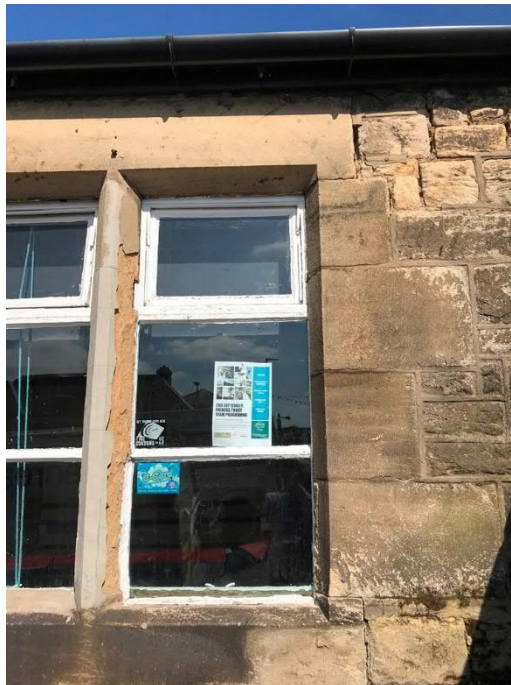
16. Defective stone mullion to The East Centre

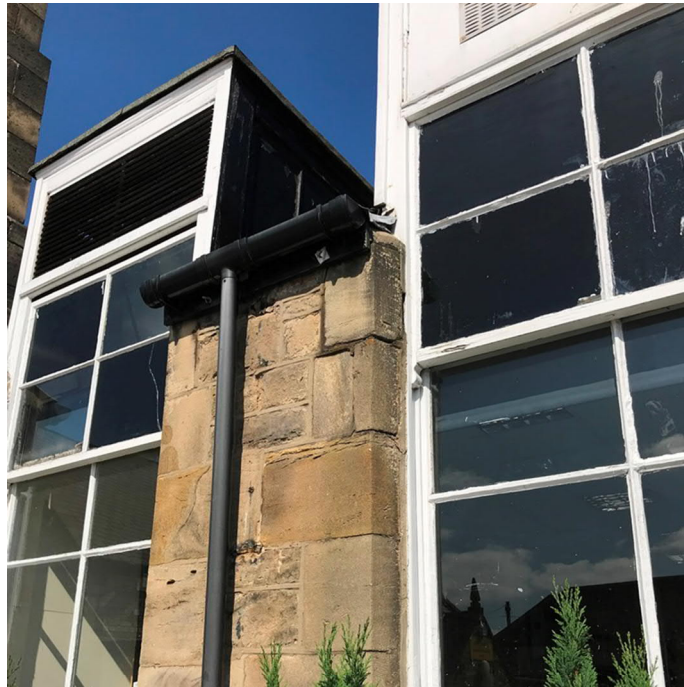
17. Outward rotation to the west facing elevation to The East Centre

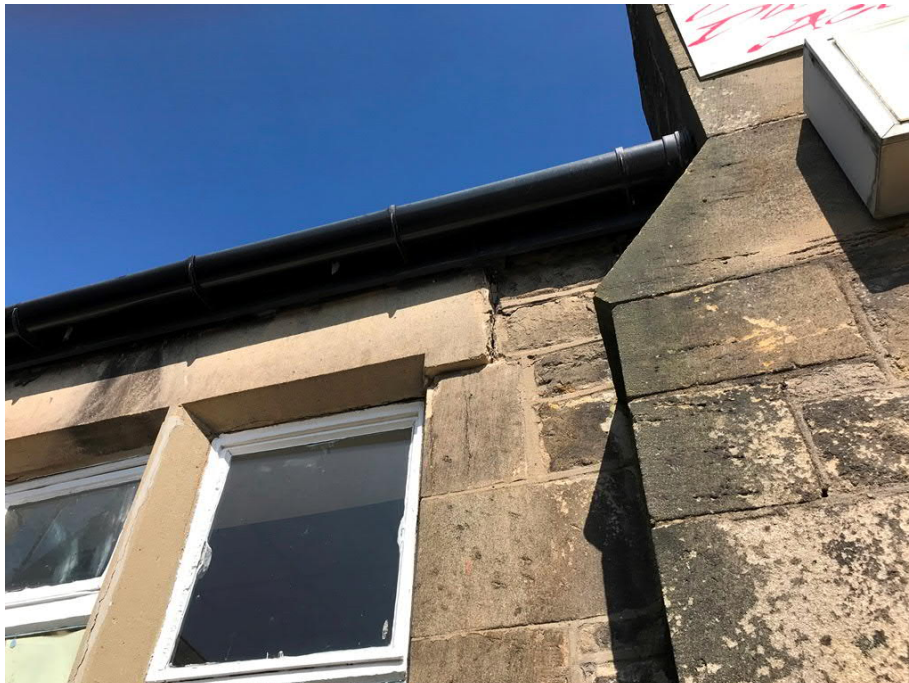
18. Movement noted to the lintel detail to the left hand side of the west elevation to The East Centre

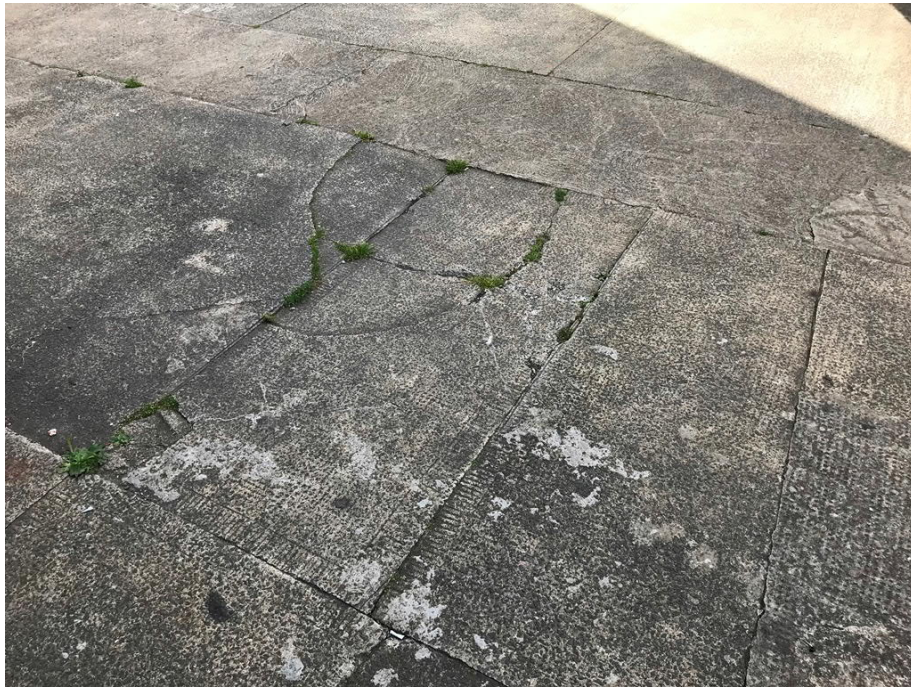
19. Sunken and cracked hardstanding to the car park area

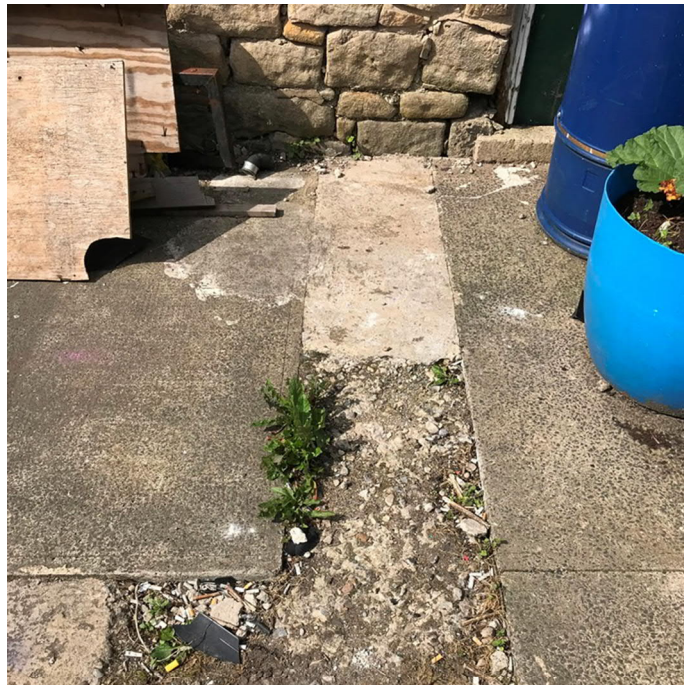
20. Deterioration to the trench detail to the car park area

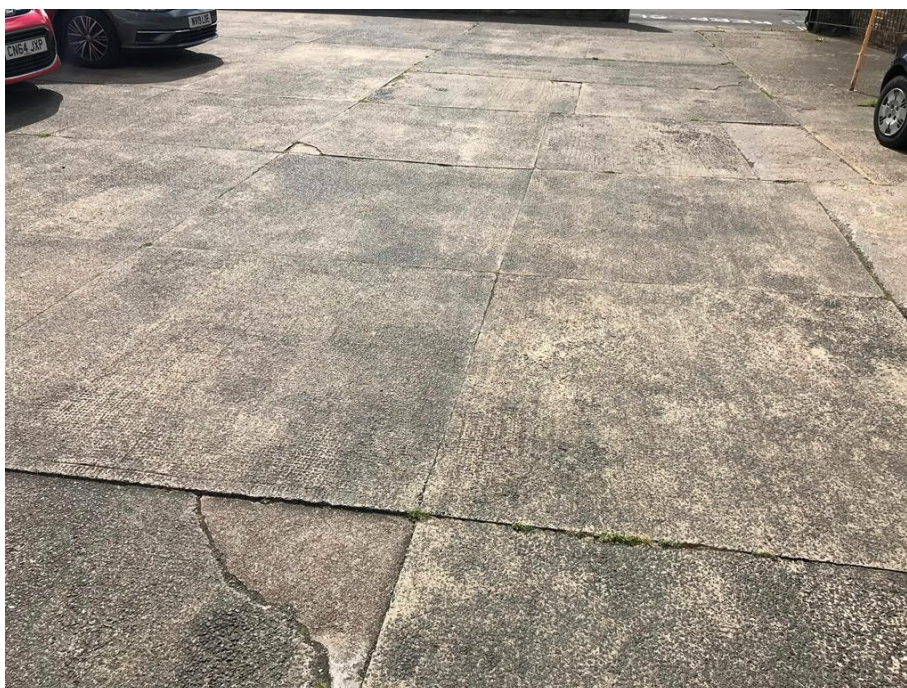
21. Undulation noted to the hardstanding bays to the car park area

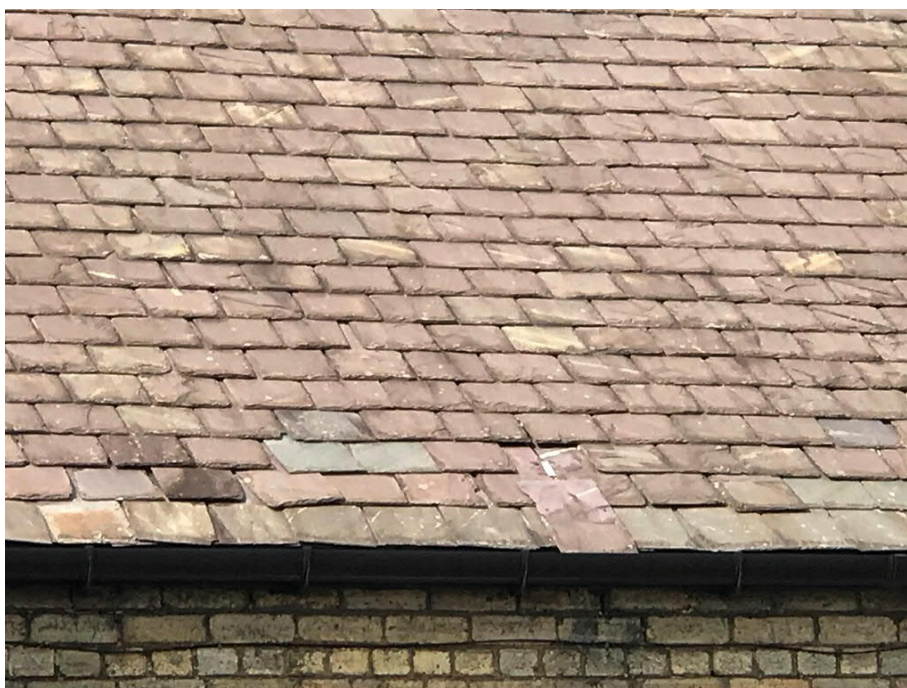
23. Slipped and chipped slates to the south roof slope to the Open Door building

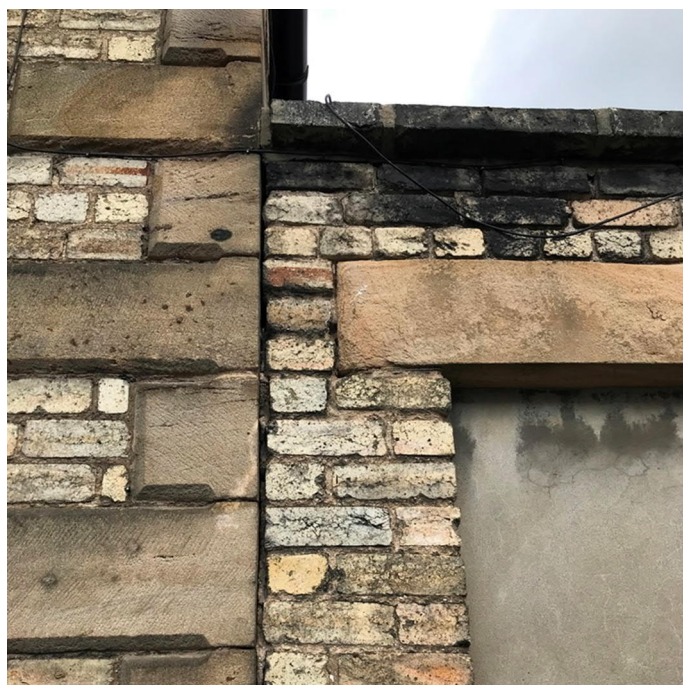
24. Open butt joint to the west elevation to the Open Door building

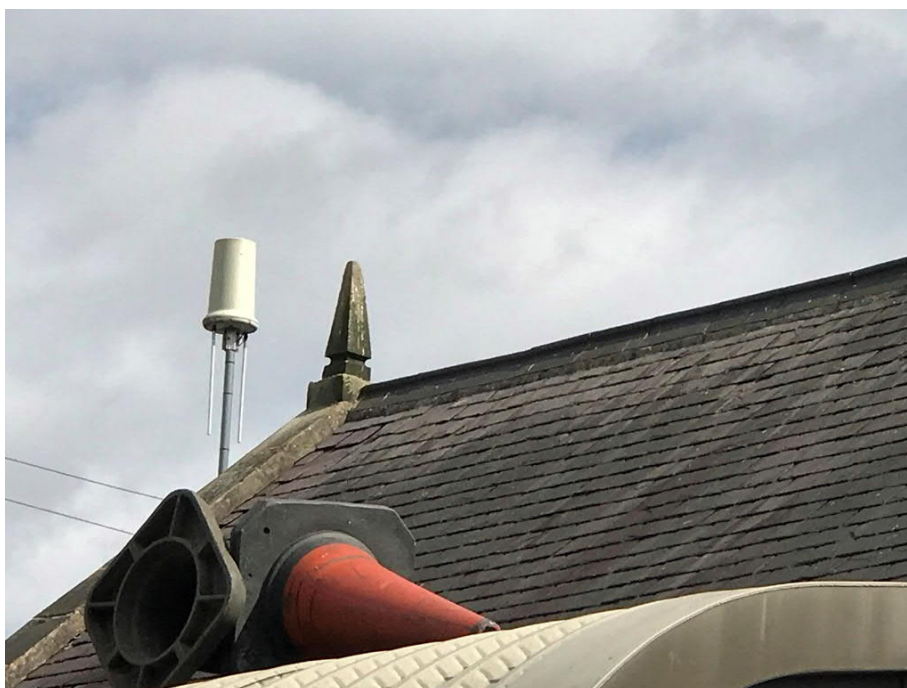
25. Cones to the mono-pitched roof to the north of the Open Door building

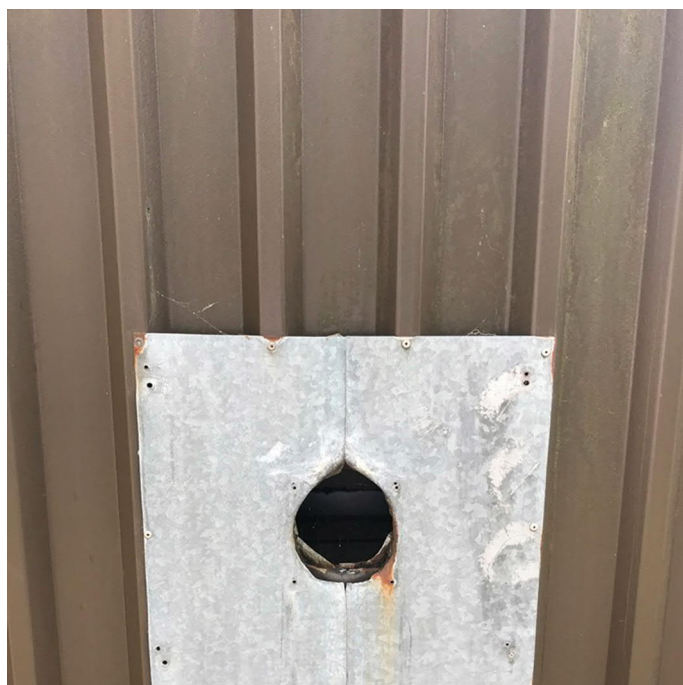
26. Missing flue/open to the north elevation of the Open Door building

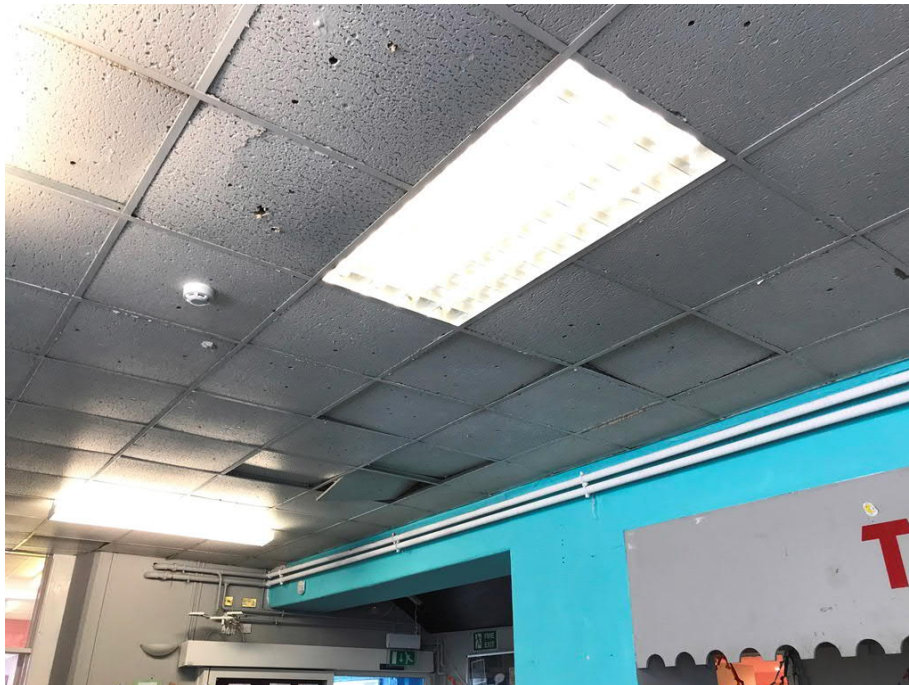
30. Damaged and defective ceiling to the open plan area to The East Centre

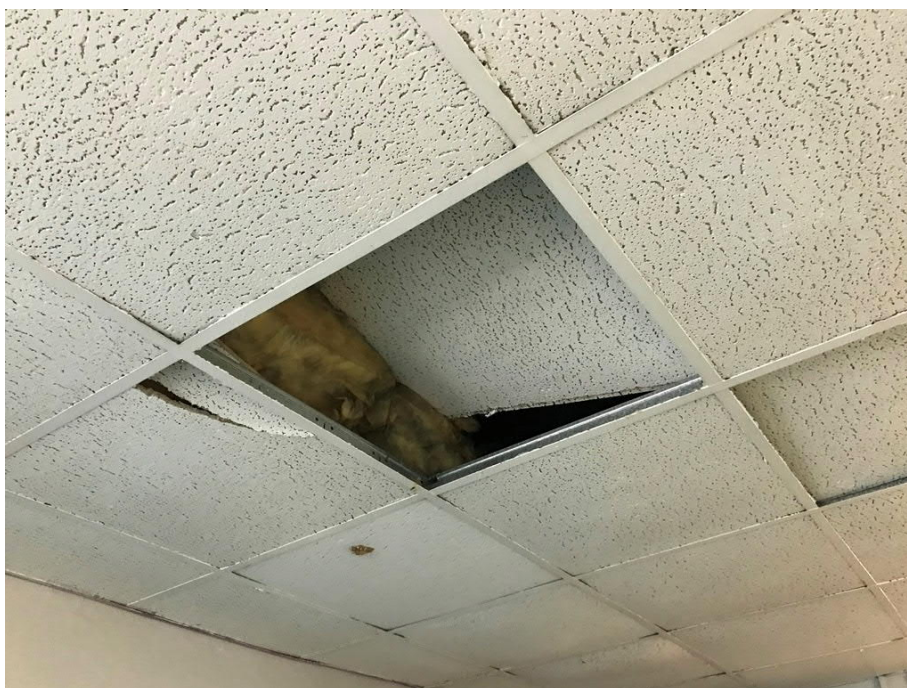
31. Insulation noted above the line of the suspended ceiling to the open plan area to The East Centre

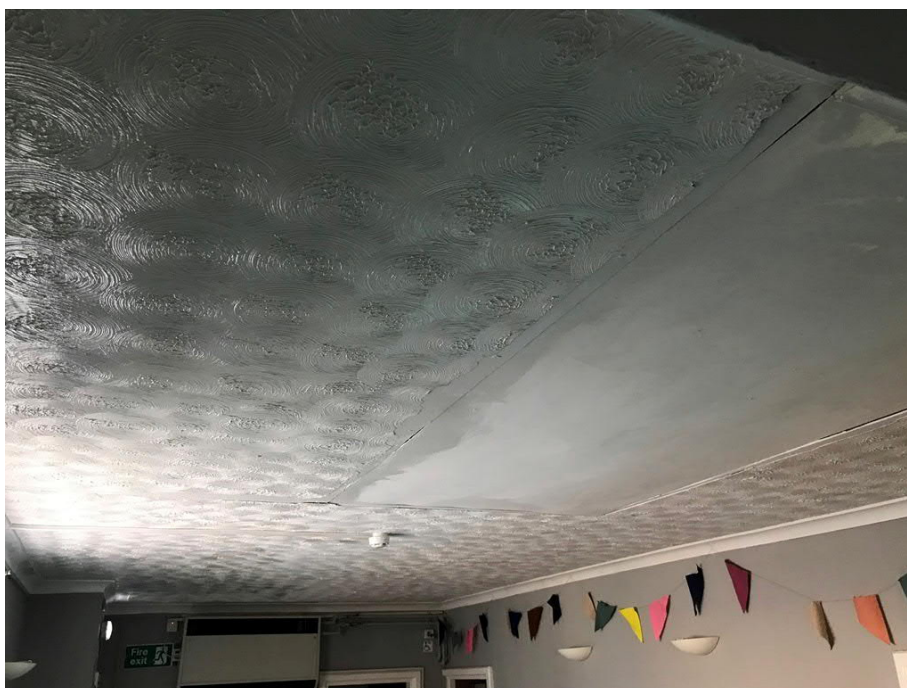
32. Evidence of artex/textured coating to the ceiling surface within the open plan area to The East Centre

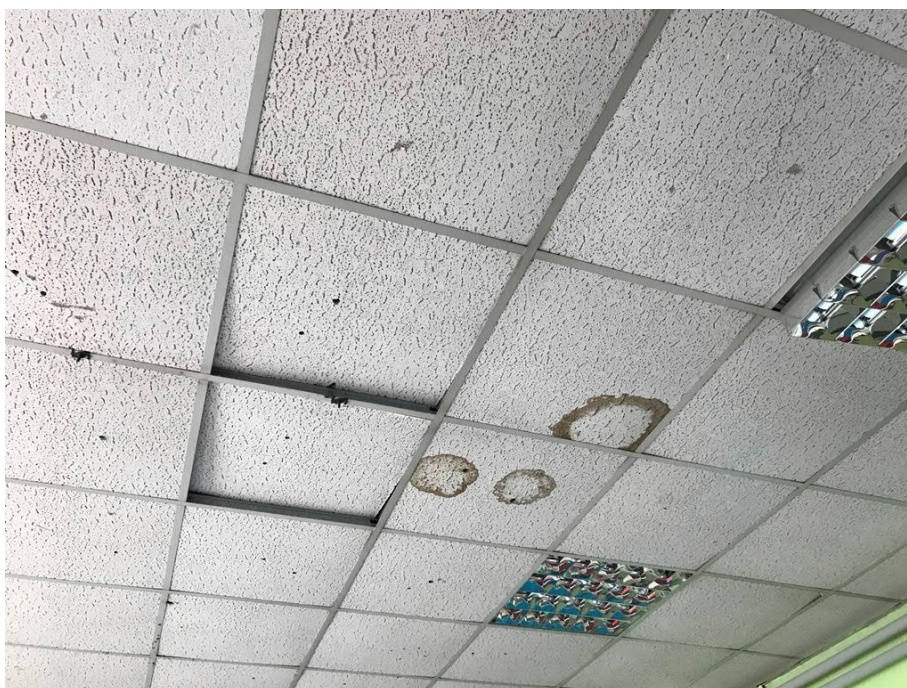
A full inspection of the felt covered roof sections above the windows within the south elevation were not inspected as access was limited and due to the extent of water stained ceiling tiles observed within the sofa room we recommend that a further high level inspection is undertaken to determine the condition of the flashing/jointing detail between the pitched and flat roof sections and if necessary undertake replacement or isolated repairs.

35. Water staining to the ceiling within the sofa to The East Centre

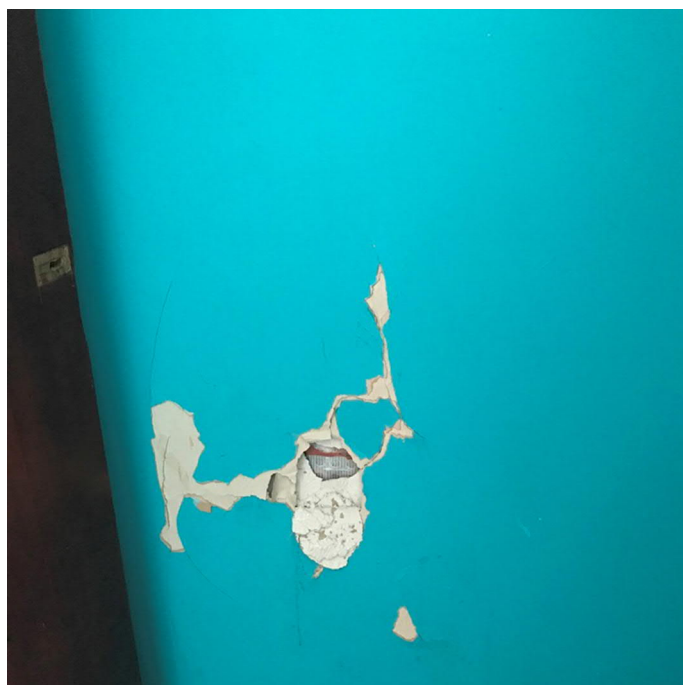
36. Damaged plaster to the male WC cubicle to The East Centre

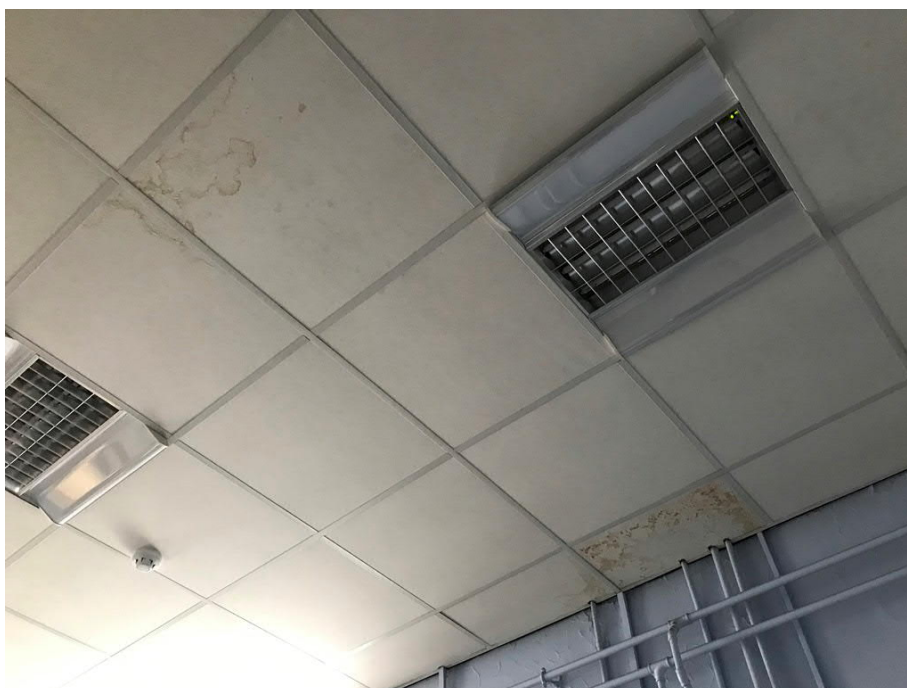
42. Soiled, stained and deteriorated ceiling within the Open Door building
