Job Number	100369699[1]
Playground	Castle Dene Playground
Date and Time of Inspection	29 April 2026 09:59:37
Inspecting Officer	Alan Hinde
Signature

Job Number	100370264[1]
Playground	Highfield Playground
Date and Time of Inspection	08 May 2026 09:33:59
Inspecting Officer	Alan Hinde
Signature

Job Number	100369716[1]
Playground	The Copse Playground
Date and Time of Inspection	29 April 2026 13:46:22
Inspecting Officer	Alan Hinde
Signature

Job Number	100370269[1]
Playground	West Mickley Playground
Date and Time of Inspection	08 May 2026 13:47:45
Inspecting Officer	Alan Hinde
Signature

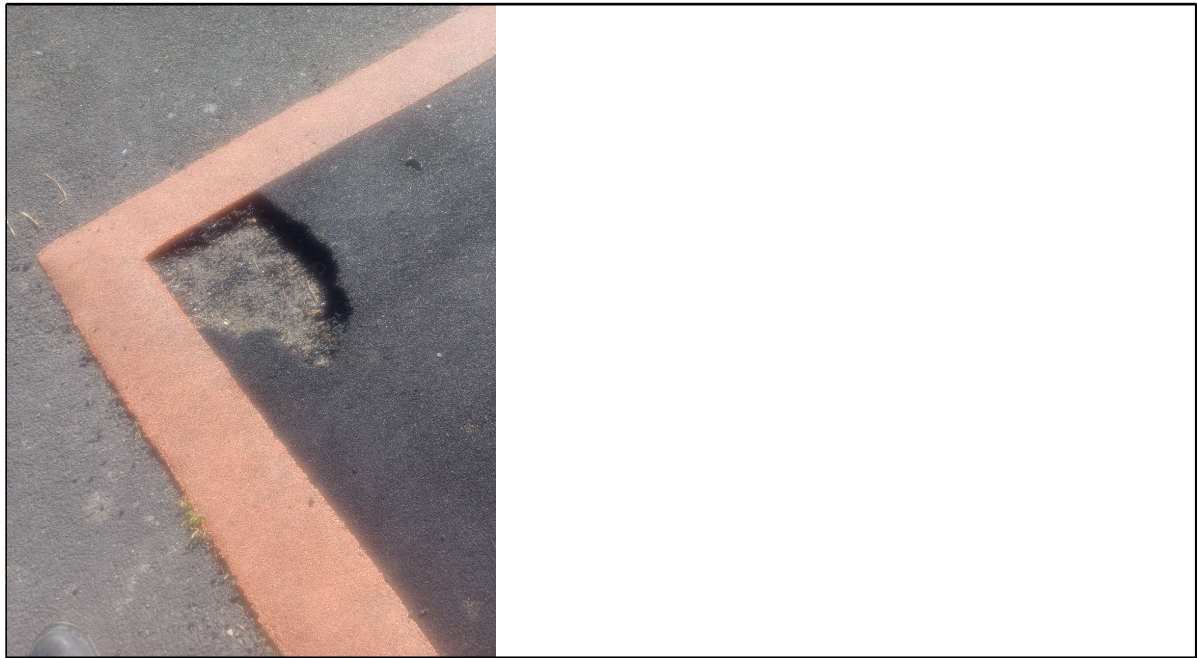
INSPECTION FINDINGS - Minor Defect, requires monitoring

Question	Response
Equipment Long Description	Climbing Frame with slide and surface
Equipment Reference	NCC001-PLAYEQ-PGPRU001_004
Equipment Make	SUTCLIFFE
Equipment status	Minor defect, requires monitoring
Detail of defect	deliberate damage to wet pour surface, trip hazard
Risk of the defect causing injury	1 - Very low - Extremely unlikely, minimal probability
Possible severity of injury caused by defect	1 - Very low - No injury likely, scratches at the most
Date of Inspection	29/04/2026

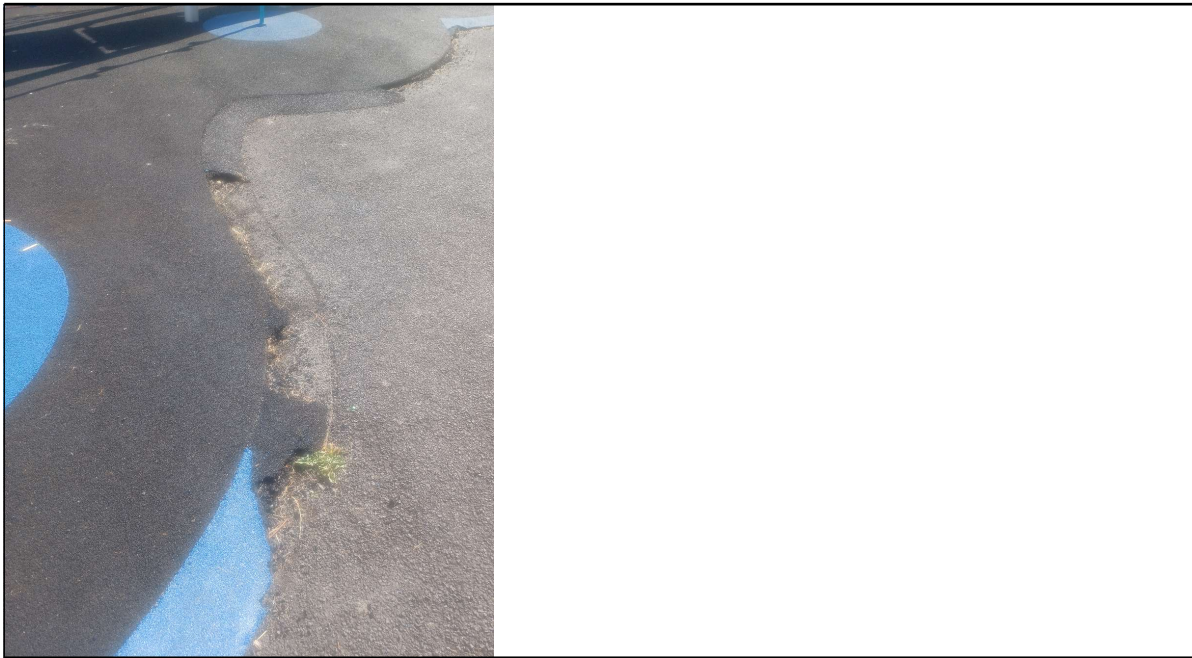
INSPECTION FINDINGS - Minor Defect, requires monitoring

Question	Response
Equipment Long Description	Large climbing frame with slide and surface
Equipment Reference	NCC001-PLAYEQ-PGPRU001_006
Equipment Make	SUTCLIFFE
Equipment status	Minor defect, requires monitoring
Detail of defect	sections of surface missing and loose
Risk of the defect causing injury	1 - Very low - Extremely unlikely, minimal probability
Possible severity of injury caused by defect	1 - Very low - No injury likely, scratches at the most
Date of Inspection	29/04/2026

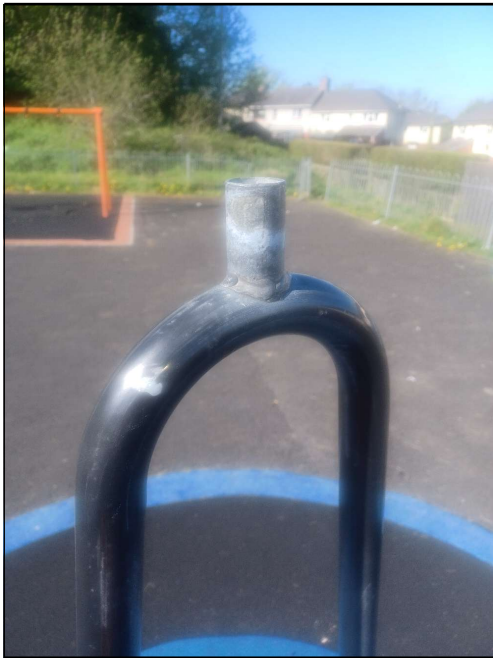
INSPECTION FINDINGS - Minor Defect, requires monitoring

Question	Response
Equipment Long Description	Spinner
Equipment Reference	NCC001-PLAYEQ-PGPRU001_007
Equipment Make	SUTCLIFFE
Equipment status	Minor defect, requires monitoring
Detail of defect	rubber stopper missing from the top
Risk of the defect causing injury	1 - Very low - Extremely unlikely, minimal probability
Possible severity of injury caused by defect	1 - Very low - No injury likely, scratches at the most
Date of Inspection	29/04/2026

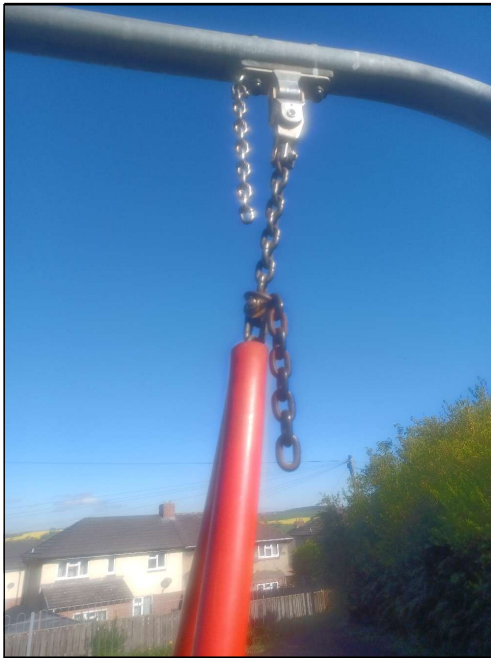
INSPECTION FINDINGS - Minor Defect, requires monitoring

Question	Response
Equipment Long Description	Nest Swing and surface
Equipment Reference	NCC001-PLAYEQ-PGPRU001_008
Equipment Make	SUTCLIFFE
Equipment status	Minor defect, requires monitoring
Detail of defect	shackle missing
Risk of the defect causing injury	1 - Very low - Extremely unlikely, minimal probability
Possible severity of injury caused by defect	1 - Very low - No injury likely, scratches at the most
Date of Inspection	29/04/2026

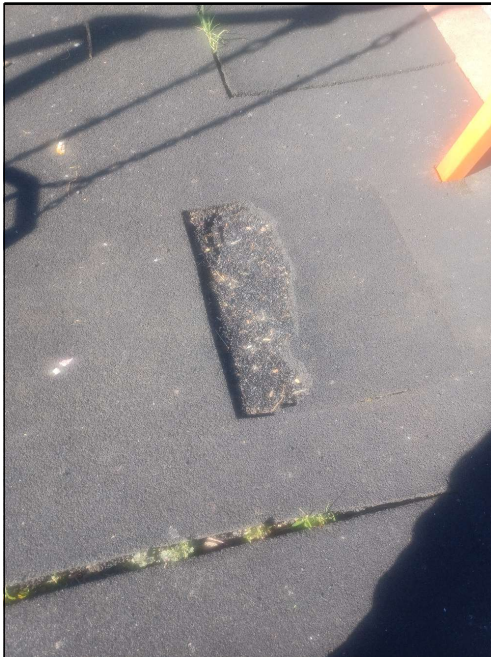
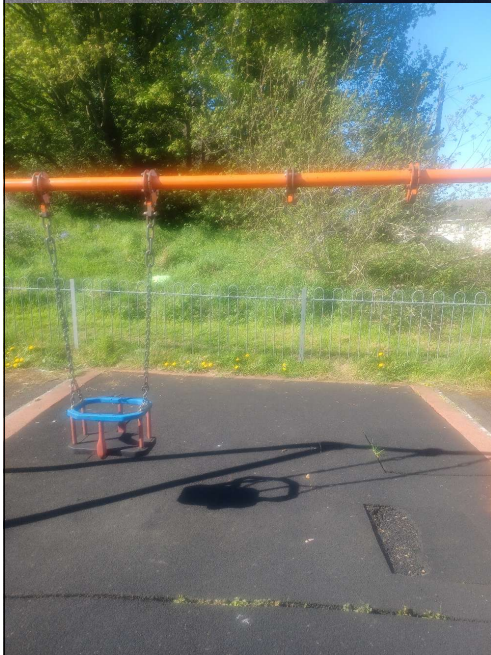
INSPECTION FINDINGS - Removed

Question	Response
Equipment Long Description	Infant Swings with surface
Equipment Reference	NCC001-PLAYEQ-PGPRU001_002
Equipment status	Equipment Removed - Temporary
Detail of defect	one of the sings has been removed because of damage to the seat section of matting missing
Risk of the defect causing injury	0 - No risk of injury
Possible severity of injury caused by defect	0 - No possible severity of injury
Date of Inspection	29/04/2026
